Trust your instincts? The challenges of surveying historic buildings

This paper is concerned with the challenges of surveying historic buildings and the various ways that these buildings have been occupied and changed over their lifetime. It considers the unusual use of sgraffito on a London building and records for bomb-damaged properties in London.

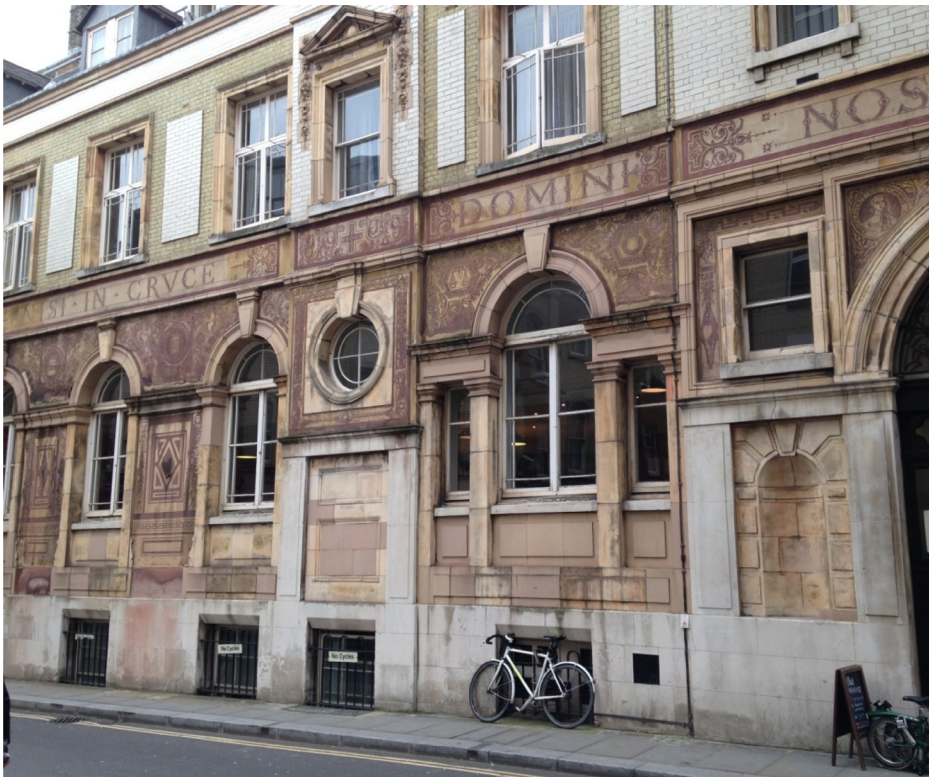
Figure 1: Sgraffito and terracotta detailing to building elevation
 Photo © Lighthouse Surveyors

Tucked behind the back of St Paul's Cathedral in the City of London is what is described as a Grade II Listed 'Victorian' building, now used as a hostel (see Figure 1). The first impression was somewhat different to that expected. The subject for survey appeared to be something more akin to a building in Venice and a Canaletto painting. The English Heritage Listing describes a

Renaissance elements including Venetian and round windows, round headed doorways and niches, the ground floor openings all in with sgraffito decoration to the intervening wall surface, the first floor openings with terracotta surrounds, some pedimented, set in brickwork with plain brick panels of shallow projection.

Of particular interest is the 'sgraffito' and fine-quality terracotta to the principal elevations.

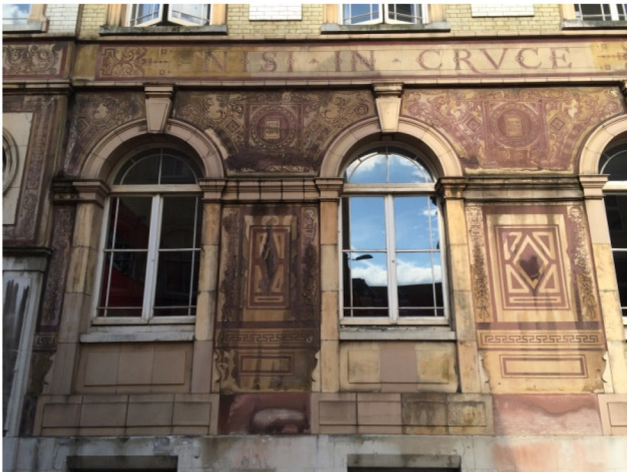
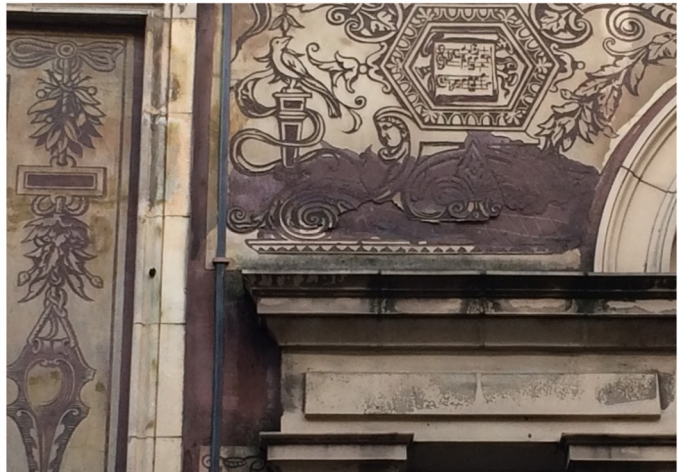
Figure 2: Severely weathered/perished sgraffito render
 Photos © Lighthouse Surveyors

Sgraffito decoration is realised with successive layers of pigmented and scratched/engraved mortar to create a colour-contrasted finish that is intended to beautify a building's facade. Sgraffito decoration combines the talents of both drawing and painting and also requires a craftsman to have the meticulousness of an expert plasterer in the application, layering and final appearance of the materials. What to do with such a decayed but

nevertheless beautiful finish is a challenge both to the philosophy of repair (eg, protect, repair or renew) and the feasibility of the procedure itself — finding someone who can complete the work is no easy task. Financial considerations are therefore very significant too.

Sgraffito is only a rendering, however, and, of course, it has a significantly reduced life span compared to that of stonework. Despite this, the examples shown here are remarkably intact, although now in need of appropriate intervention.

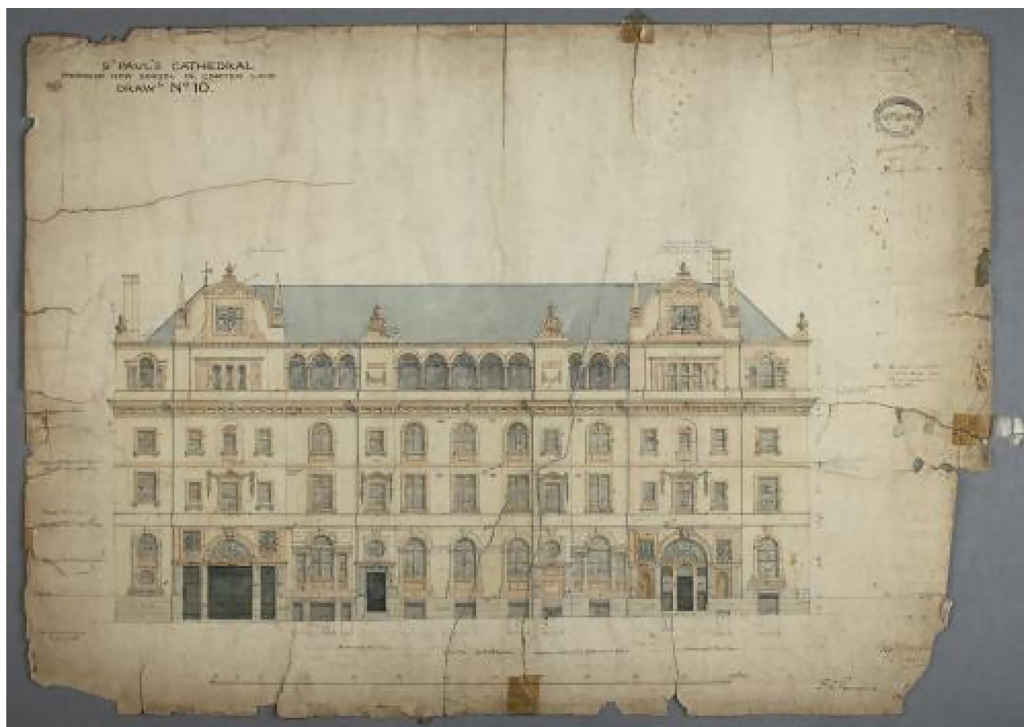
Figure 3: The original design

Further research in the archives at St Paul's Cathedral, however, revealed that the original designs proposed a much taller building than the existing one and one that was finished with a pitched roof. It is not certain, however, that this design was ever built and, of course, there have been two world wars between the date of construction and now.

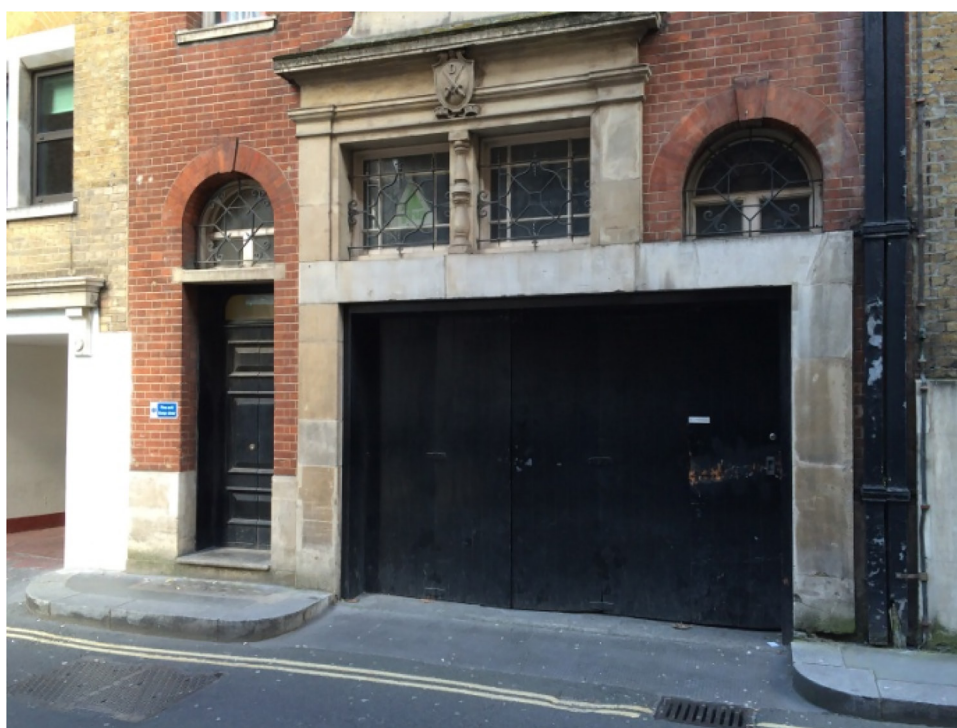
Figure 5: The original coach house entrance

research revealed that the building originally incorporated an internal coach house. The height requirements for the coach and horses (as shown in Figure 5) necessitated higher than normal ceilings and internal mezzanine floors above the coach house, different to the ceiling height in the main building.

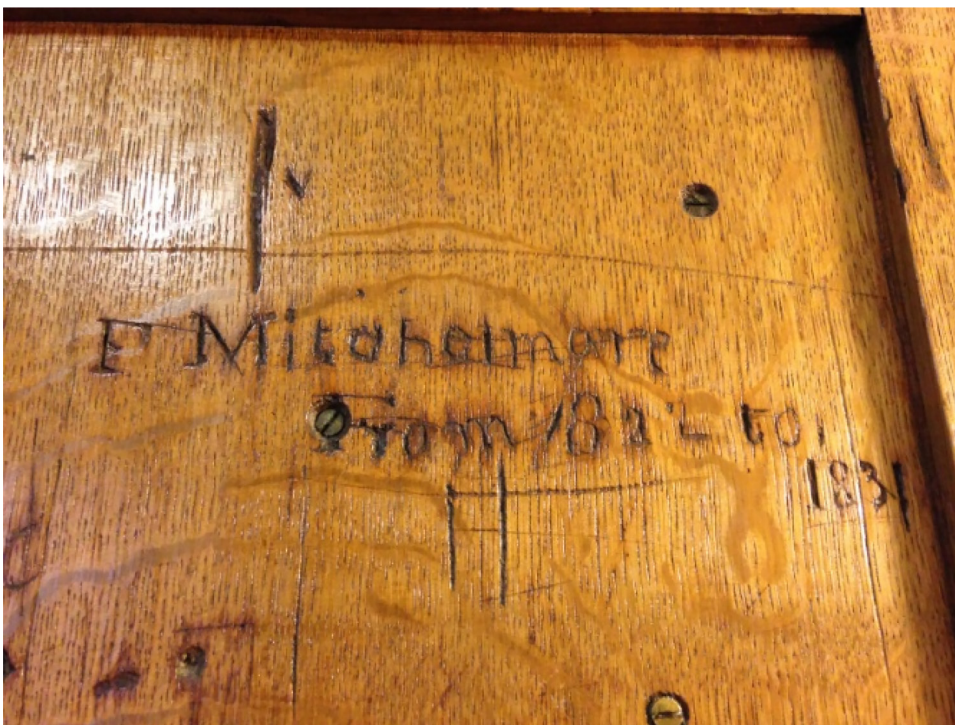
Figure 6: Graffiti on the oak cladding

Despite some confidence in being able to date the building to 1874 from historic archives and English Heritage's website the trail was temporarily lost when some fascinating graffiti dating back to 1832 was uncovered within an oak clad room. Indeed, the room was peppered with the engraved and dated initials of various occupants, although troublingly many of the dates were well before the building was actually constructed. We can do no better than assume that the valuable oak cladding was considered worthy of retention and reuse and thus salvaged from an older building. As is often the case even with the benefit of what appear to be well-researched archival records, the written record and the building do not always align.
