# Common defects surveyors encounter in Victorian and Edwardian properties

**Ian Rock**

## ABSTRACT

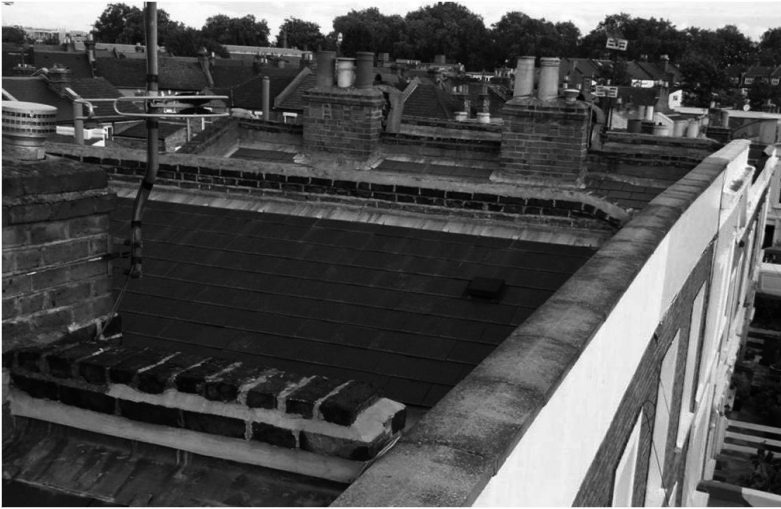
**Figure 1:** Parapet wall on a early Victorian 'butterfly' roof (aka 'London' roofs)

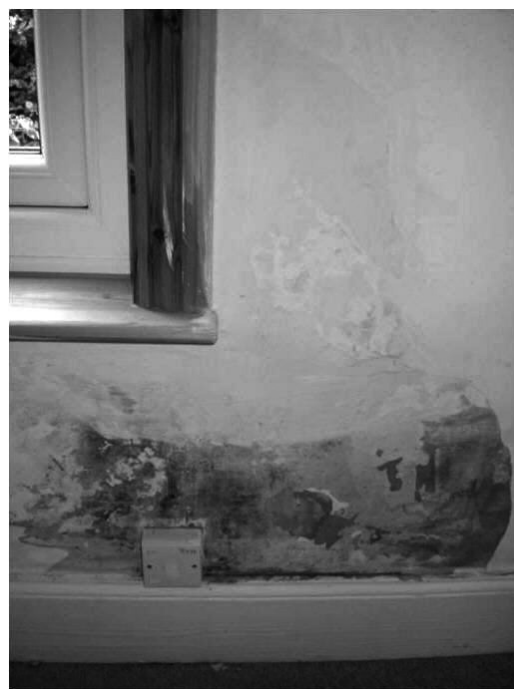
Figure 2: Damp — but not necessarily 'rising'

True 'rising damp' due to a defective or missing DPC is extremely rare.<sup>8</sup> The two main sources of moisture to lower walls are high external ground levels or excessively wet ground. Earth banked up against a wall or a raised concrete path can force moisture into the wall. Marshy ground can result from a variety of causes such as persistent gutter leaks, a low-lying site, high water table or defective underground branch drains allowing water to seep into the ground, causing low-level dampness to persist unseen under suspended floors.

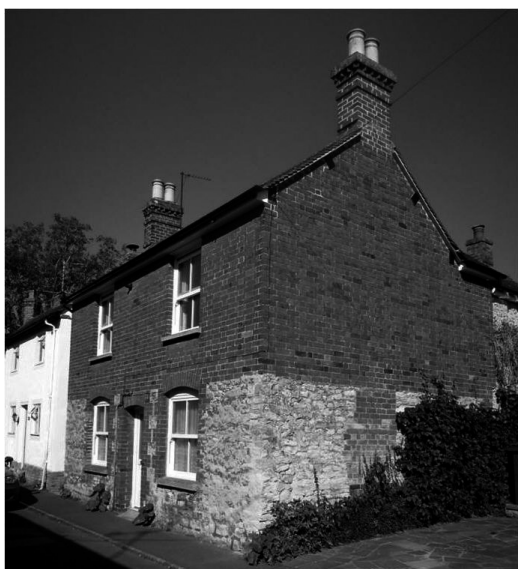
**Figure 3:** High ground levels are a common cause of low level damp

fittings, damaged drains, eroded sills, cracked pipes etc. High ground levels should be reduced to at least 200mm below internal floor levels and concrete paths replaced with shallow gravel-filled 'French drains' excavated around the lower walls to facilitate evaporation of moisture from the base of the wall. Condensation may be initially reduced with dehumidifiers and heating, but an effective programme requires improved air extraction, a good flow of ventilation and upgraded insulation to cold surfaces as well as a reduction in moisture emissions.

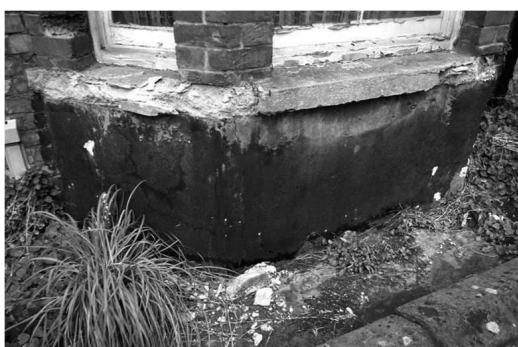
**Figure 4:** Extreme example of eroded sills resulting in damp to lower walls and floor structure

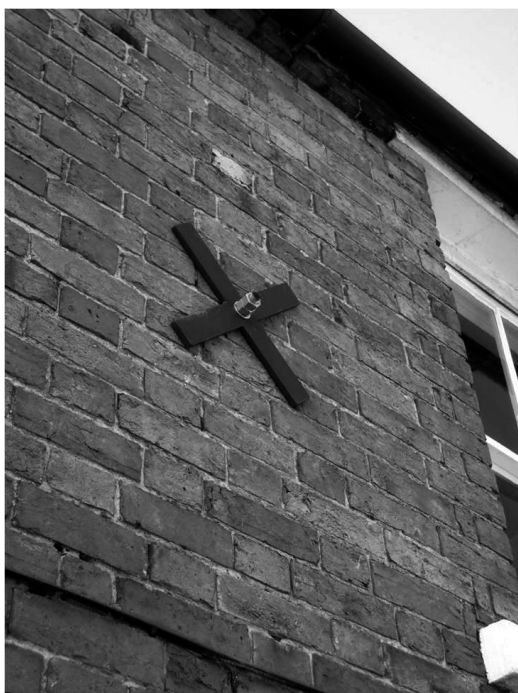
**Figure 6:** Traditional method restraint applied to bowing walls

Flank walls were commonly built with floor joists running parallel to them, hence very little lateral restraint was provided. Over time these unrestrained expanses of masonry have a tendency to bulge out, eventually requiring remedial work in the form of ties fixed through the wall to floor joists (assuming the wall is still stable). Similar problems can occur where the main front elevation walls on some terraces were not effectively tied to the party walls. Similarly, some apparently solid external walls were cheaply built as twin

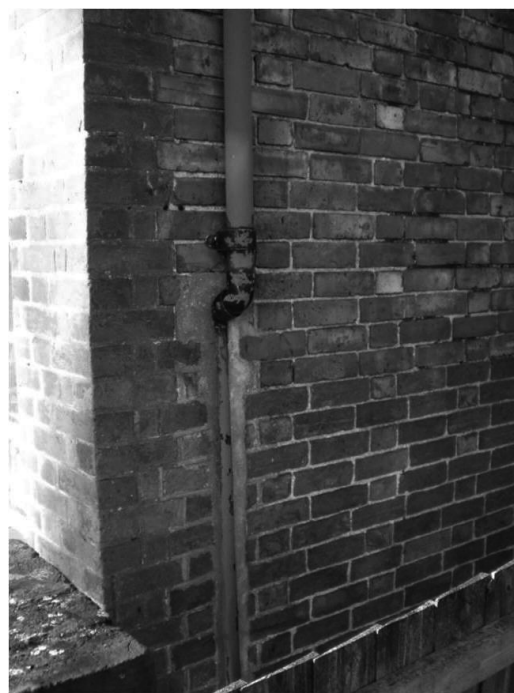
**Figure 7:** Embedded cast iron downpipe — an inherent defect dating from the time of construction

- Unrestrained main walls, gables and parapets
- Thin walls (single width ‘4.5in’ brick rear additions and bays)
- Under-structured floors
- Joist ends embedded in solid masonry walls
- Timber inner lintels embedded in porous walls
- Cast iron downpipes embedded in walls or inaccessible for painting
- Hidden valley and parapet gutters and hoppers
- Lack of DPCs to stacks, parapets and to some pre-1875 main walls
- Lack of inspection chambers for accessing underground drain runs

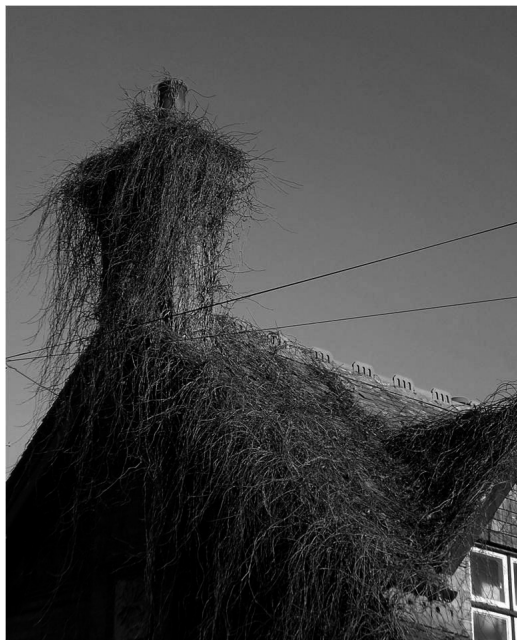
**Figure 8:** Example of long term neglect — a common cause of defects

- Blocked, leaking or corroded gutters and downpipes
- Blocked, leaking or damaged drains
- Eroded pointing to walls, stacks and parapets
- Leaking flashings
