# Condensation in loft spaces: Myths and realities

**Phil Parnham**

**Keywords:** *loft space condensation; loft insulation; loft ventilation*

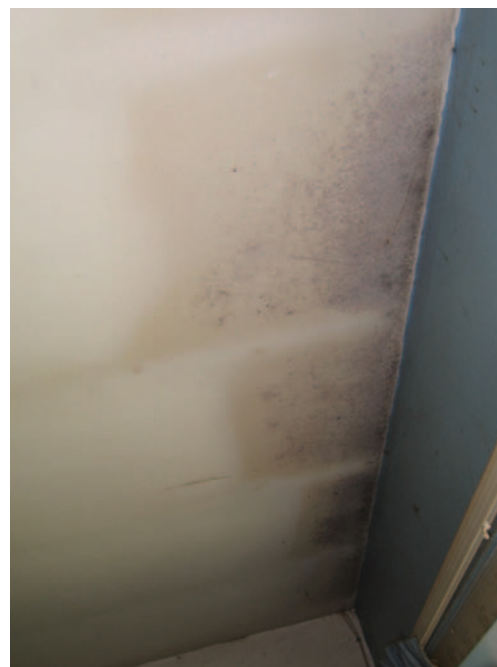
**Figure 2:** Above this ceiling, the loft insulation has not been pushed up to the back of the wall plate and taken over the head of the wall. Condensation and mould growth has formed on the resulting cold areas. This is still visible despite being cleaned with diluted bleach

High levels of water vapour is not the only cause of problems in loft spaces as discontinuities in thermal insulation can also cause localised condensation. Often called ‘cold bridging’ or ‘thermal bridging’ it occurs where part of a structure has lower thermal resistance components. This can result in cold surfaces on which condensation, mould growth and/or pattern staining can occur.<sup>8</sup> Figures 2 and 3 show a typical example.

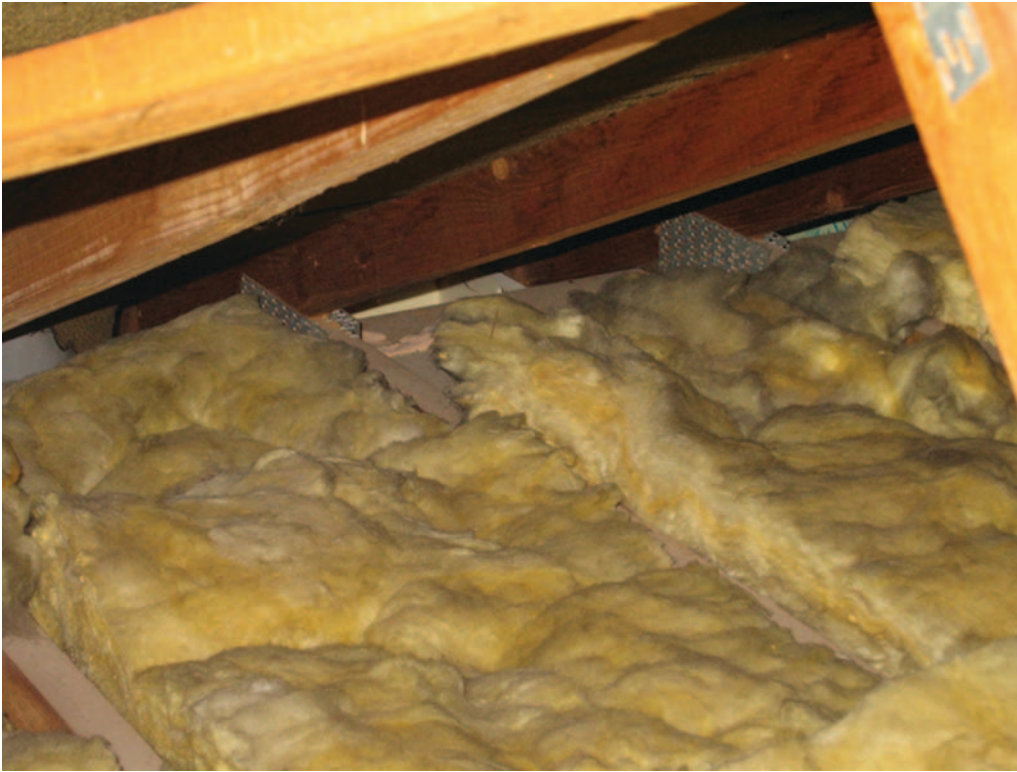
**Figure 3:** This is the view of the same ceiling shown in Figure 2 but from within the loft space. The insulation is approximately 75mm thick and upgrading this to 250–70mm while maintaining roof space ventilation would be a challenge

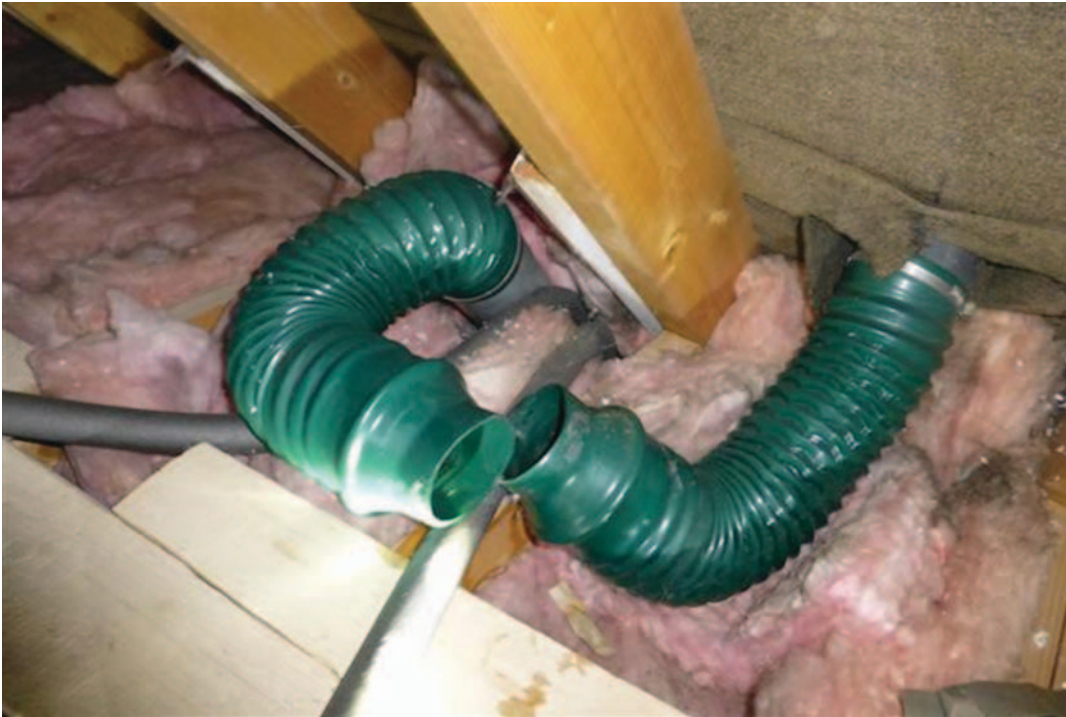
**Figure 4:** This flexible duct should connect the extract fan from the bathroom to the ventilating tile in the eaves of the roof. Because the wrong ducts have been used, it is impossible to join these effectively allowing warm moist air to get into the roof space

are becoming a common sight in many lofts. These can be from extract fans to a bathroom or more sophisticated whole house systems. If these are poorly fitted and the flexible ducts fall away from the ventilators, the appliance can deliver large amounts of warm and moist air into the loft (see Figure 4).
